# Manhole Inspection Summary

Manhole # S45E\_\_052MH

Insp Date: **7/23/08 10:24 AM**

**Location** Address: **Washington**

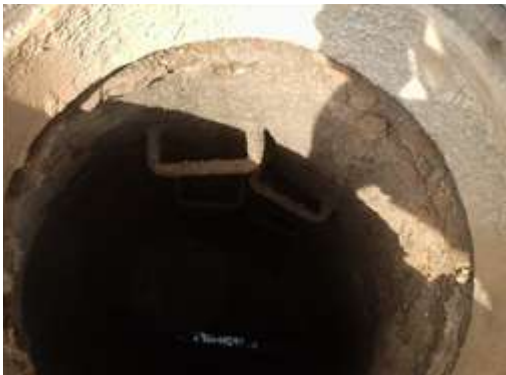
Defect 1

☒ **Leaks**

Frame Leaks

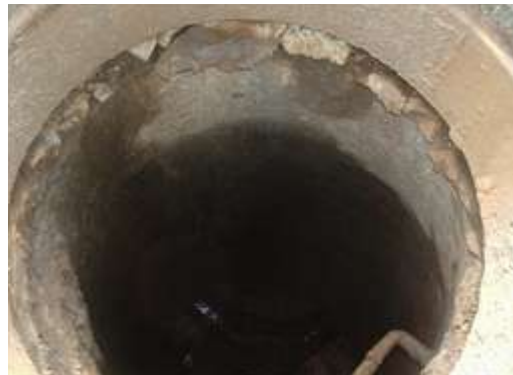
Defect 2

Condition: ☐ Sound ☐ Cracked ☐ Root Intrusion ☒ **Loose Brick** ☐ Deteriorated

Infiltration: ☐ None ☒ **Joint** ☐ Cracks ☒ **Mortar** ☐ Roots ☐ Wall

Loose Brick

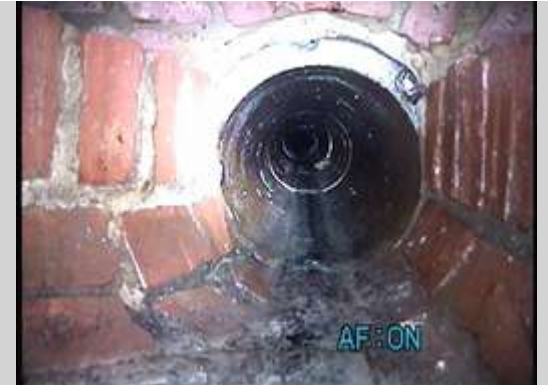
12 O'Clock Outflow

8 in. Circular Gravity Sewer  
Pipe Out @ 12 O'Clock

Pipe Height: **8.4** (in.) Rod and Bar (Angled)  
Pipe Material: **Clay** ☐ Pipe Lined  
Invert Depth: **11.50** (ft.) Flow Characteristics: **Slow**  
Deposits: ☒ None ☐ Mud ☐ Sludge ☐ Debris ☐ Grease  
Silt Depth: (in.) Deposits Extent:  
Infiltration: **None** Pipe Seal Cond: **Sound**

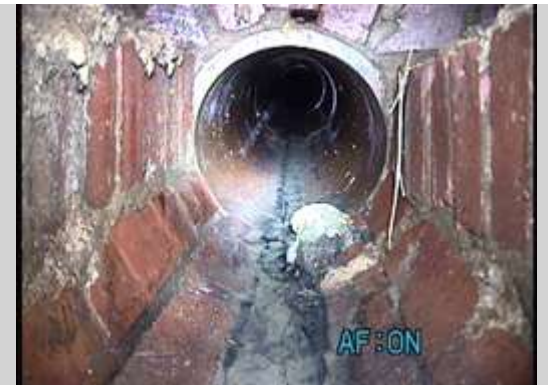
6 O'Clock Inflow

8 in. Circular Gravity Sewer  
Pipe In @ 6 O'Clock

Pipe Height: **8.4** (in.) Rod and Bar (Angled)  
Pipe Material: **Clay** ☐ Pipe Lined  
Invert Depth: **11.40** (ft.) Flow Characteristics: **Slow**  
Deposits: ☒ None ☐ Mud ☐ Sludge ☐ Debris ☐ Grease  
Silt Depth: (in.) Deposits Extent:  
Infiltration: **None** Pipe Seal Cond: **Sound**

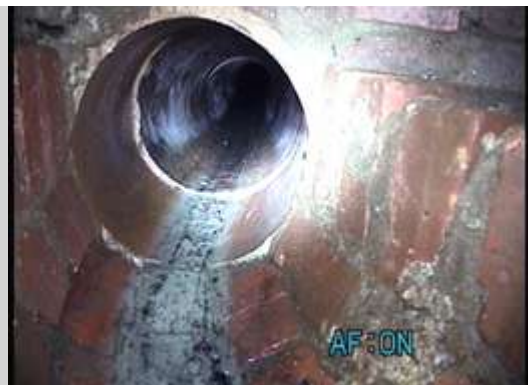
9 O'Clock Inflow

8 in. Circular Gravity Sewer  
Pipe In @ 9 O'Clock

Infiltration: **None** Pipe Seal Cond: **Sound**
